**CONNECTICUT RIVER BASIN
CONWAY, MASSACHUSETTS**

**ROARING BROOK DAM
MA 01056**

**PHASE I INSPECTION REPORT
NATIONAL DAM INSPECTION PROGRAM**

AUGUST 1981

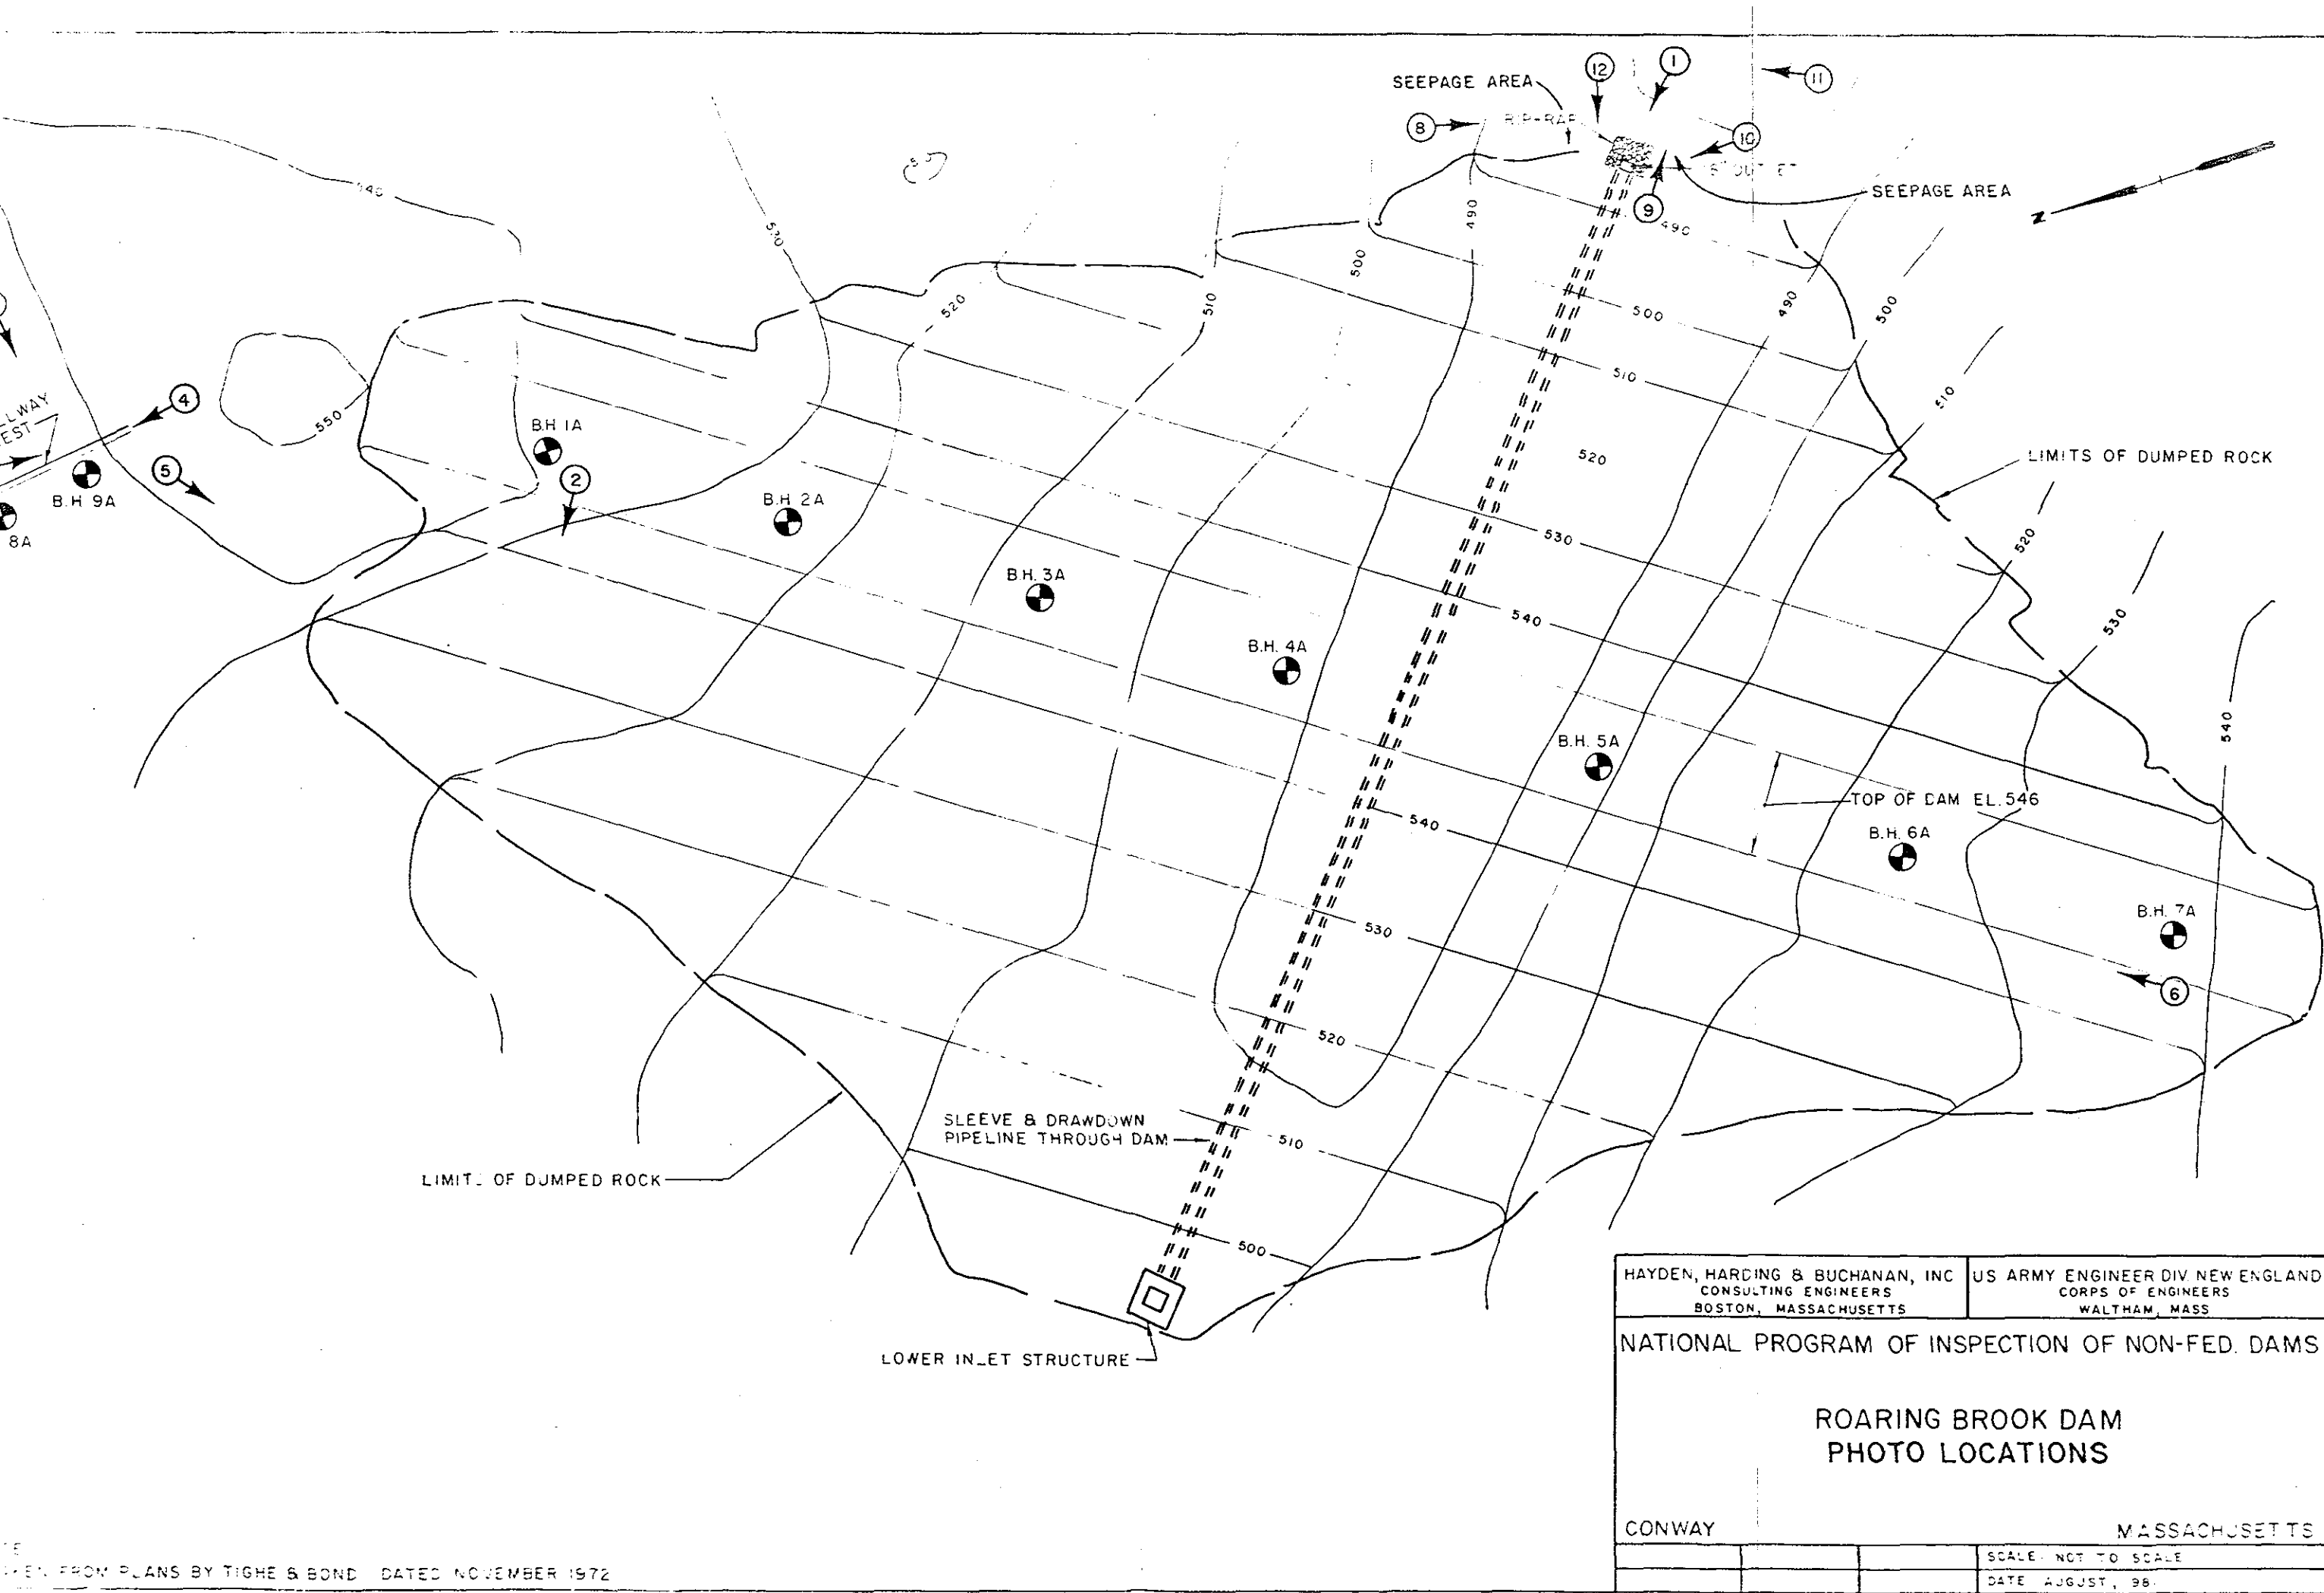
PHOTO NO. 1 - Downstream slope from outlet channel.

The downstream slope, shown in photograph 1 is constructed with four 4-foot-wide berms at intermediate levels. The slope is fully covered with riprap and is constructed at a slope of 1.5H:1V.

c. Evaluate the stability of the downstream slope of dam for all design conditions.
